### **PROJECT:** Restoration of King Street Station, Seattle, WA

**ARCHITECT:** ZGF Architects, Seattle, WA; Tim Williams, associate partner, project manager; Dave Grant, landscape architect

# On the Right Track

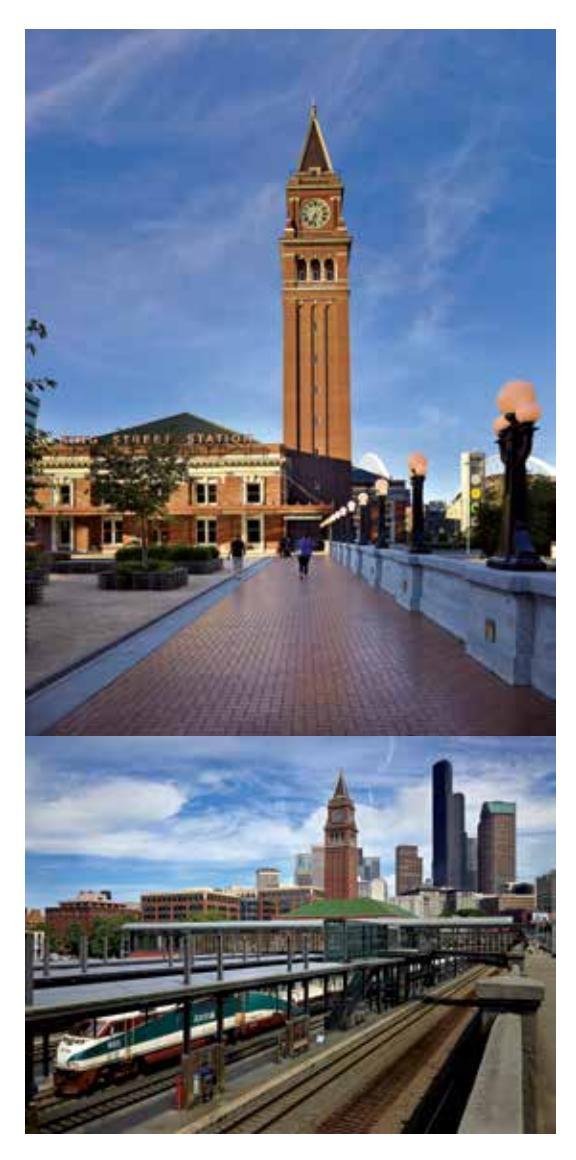
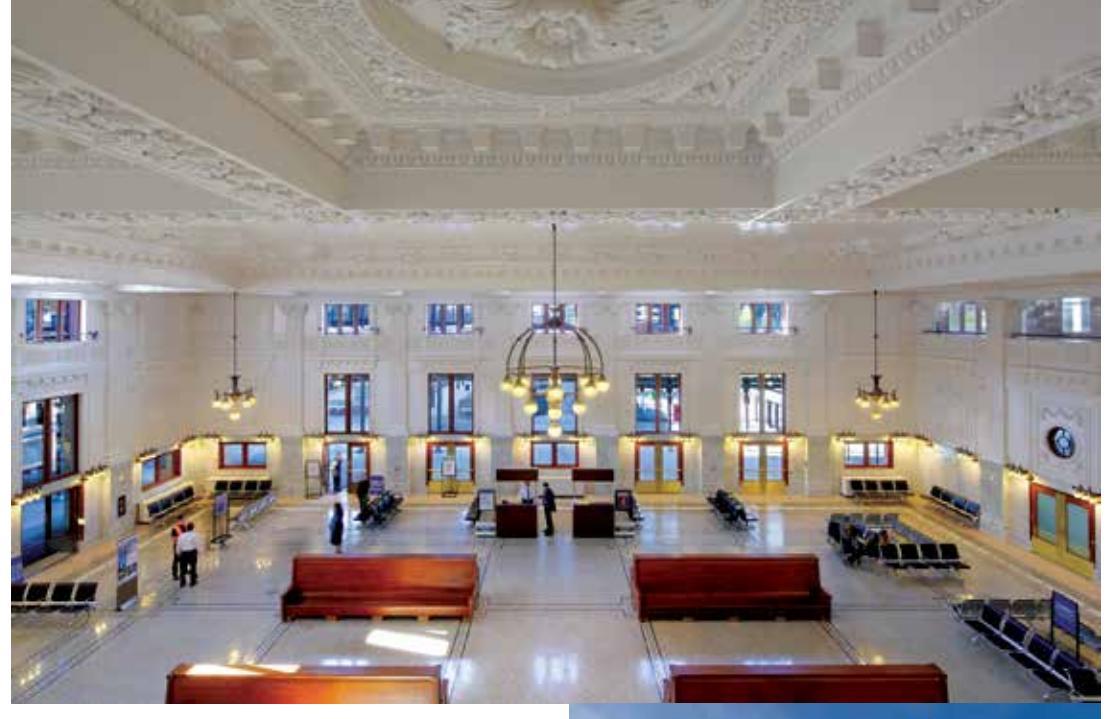
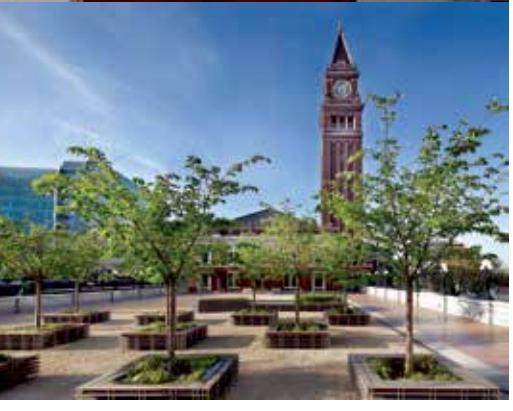
CLOCKWISE FROM LEFT: The King Street Station tower has once again taken its rightful place as an important marker in Seattle's skyline. Photo: Benjamin Benschneider. Restored to its original grandeur under the direction of ZGF Architects, Seattle's King Street Station, seen here from the Jackson Street plaza, serves as a center of the city's transportation hub. It received a LEED Platinum rating. Photo: Benjamin Benschneider. The historic main waiting room with its 34-ft. ceilings and ornate plaster has now been restored to its original beauty. All lighting fixtures in the main waiting room are historic replicas with energy-efficient LED lighting. Photo: Doug Scott The Jackson Street Plaza was formerly a parking lot. Photo: Doug Scott

The building is on an 18-ft. grade with Amtrak located on the first floor at the King Street level while the second floor exits on to Jackson Street. The Jackson Street Plaza, formerly a parking lot, is the roof of the first floor. It is now a public gathering space.

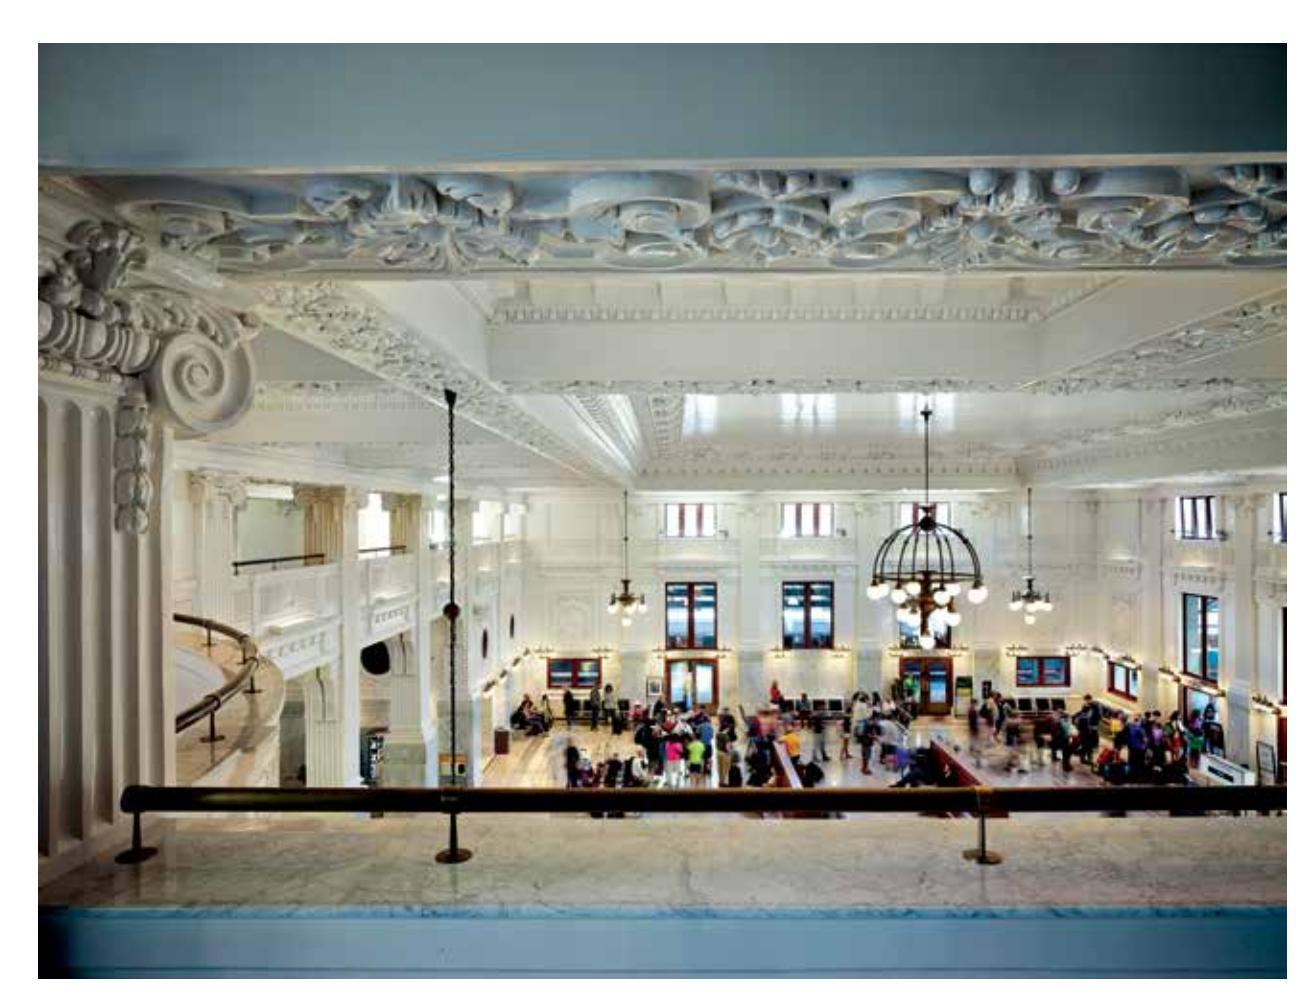
LEFT: The plaster work on the ceiling and throughout was repaired and reproduced by EverGreene Architectural Arts. Photo: Benjamin Benschneider. ABOVE: The terrazzo flooring was in fairly good condition. It required only rebuffing. Photo: Benjamin Benschneider. BOTTOM ROW, FROM LEFT: The historic main waiting room offered travelers an elegant welcome to the city. Photo: courtesy of Green Building Services. A modernization in the 1960s lowered the ceiling in the main waiting room by 10 ft. and changed the character of the room. Photo: courtesy of Green Building Services. When restoration began, the architects found that holes had been punched in the original plaster ceiling to support the lowered ceiling that was added in the "modernization." Photo: Ralph DiNola, Green Building Services

While people passing through the station probably won't notice all of the new steel, they are sure to notice the new ornate plasterwork in the grand 8,000-sq.ft. main waiting room with its 34-ft. ceilings. EverGreene Architectural Arts of NYC set up shop in the station and re-created and repaired all of the historic molding in the main waiting room. The work included re-creating all of the vertical plasterwork above the 8-ft. marble wainscoting and repairing and replacing the original ceiling. In many cases, new molds had to be created.

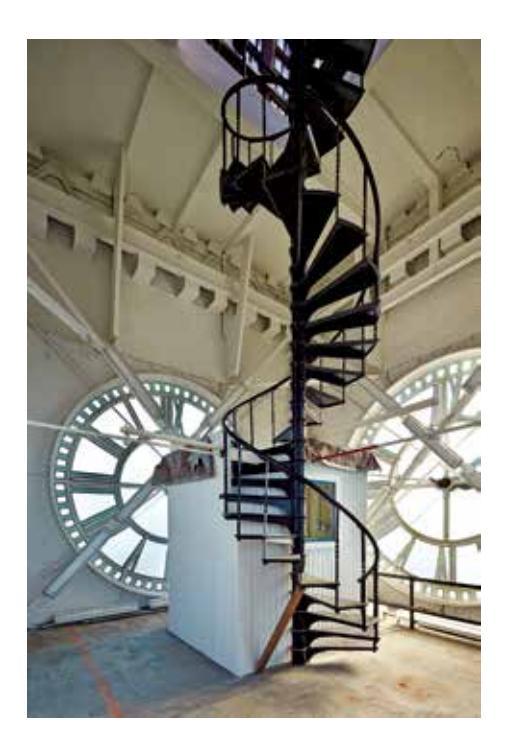
**LEFT: A spiral staircase leads up into the clock tower.** Photo: Benjamin Benschneider. **ABOVE: Natural ventilation has been returned to the main waiting room as part of the rehabilitation. This was a significant factor in obtaining the LEED platinum rating.** Photo: Doug Scott
